Lightning Induced Damage in Floor Heating Cables

Abstract— Modern day electric floor heating cables can now be found under tiles and carpet, in a cement screed or within the concrete base of a floor. Unfortunately, increasing extreme weather events and their associated thunderstorms are having a noticeable impact on electric floor heating installations in Australia. There are patterns of failures emerging that implicate lightning induced mechanisms because these patterns often differ from those found on AC mains distribution systems. This paper describes the key features of the main types of floor heating systems installed in Australia and then presents examples of damage, most likely due to lightning because of corroborating evidence, that have been collated over many years. Suggestions for the mechanisms that may be at play are made along with possible solutions being investigated for mitigating this increasing and costly problem.

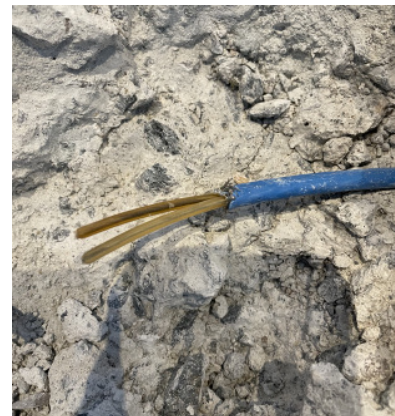
When a floor heating system is turned “on” at the start of winter, and one or more cables fail to operate, lightning could be the cause. The system may have operated successfully at 240 V for over 10 years. When the damage is located in a twin active conductor cable (single ended), there is often a noticeable colour difference in the two internal heating wires, as shown in Figure 2. One of the pair will show signs of overheating of both the “Teflon” insulation and the copper conductor. As both conductors are of the same resistance, length and insulation they would be the same colour. When removing the Teflon, to further test the cable, the copper conductor will break down and disintegrate. This conductor is usually found to be connected to the Neutral of the supply. It is suspected that the Multiple Earth Neutral (MEN) connection, along with the standard 6 mm² main earth conductor, cannot fully divert the incoming short-duration, high-voltage, high-current transient. A “weak spot” in the cable, due to minor impact damage, will allow lightning to pass from the Active conductor to the Earth Screen and to the surrounding earthed floor.

Figure 2. Colour difference after damage to heating wires.

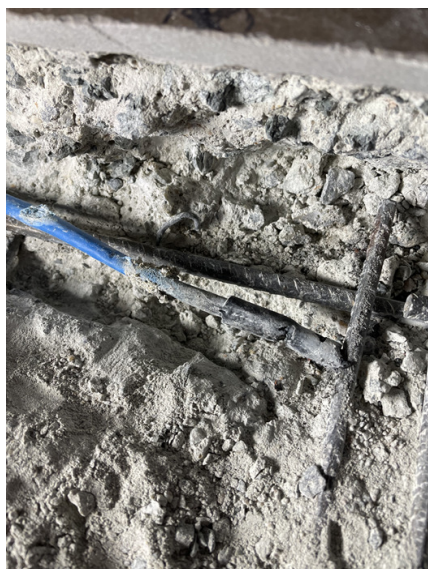
As an example, a lightning strike was reported to have severely damaged a Main Distribution Board (MDB) and an attached standby generator. The MDB supplied a fruit packaging plant and a separate domestic residence. Two single-ended, 30 W/m, in-slab heating cables in the residence failed along with a 20 W/m upstairs bathroom single-ended floor heating cable. The upstairs bathroom in-screed cable failed at approximately 8% of its length from the end junction. The point of failure was at a horseshoe shaped loop in the cable which was blackened and burnt. The blackening only extended a short distance either side of the loop with the remainder of the cable testing OK. On the ground floor, there were three identical in-slab 125 m cables installed within a large area. All three cable connections to the supply were at the same location. Initial testing showed both cables had failed at the end junctions. The third cable tested OK.

When the end junctions were located, and the concrete removed, there were signs of arcing from the end of the junction to the metal reinforcing mesh, as shown in Figure 3. Analysis of the junctions showed both to be well constructed with a crimp lug and two layers of glue lined shrink tubing. The cable earth screen was well clear of the crimp connection and did not show signs of arcing. There was wax present within the earth screens and one of the two active conductors showed discolouration on both cables. The failed junctions were replaced, the cables fully tested and all three operated as designed. Two years later, it was advised that the third cable had failed following another known nearby lightning strike. There was no other electrical equipment damage reported at this time. A similar end junction failure, with arcing to the metal reinforcing mesh, was found. The cable was repaired, tested and operated OK. Other instances of cable failures, following a known lightning strike have been recorded, but only on cables of 125 m or 150 m length. Shorter lengths of cables have been installed in larger numbers with lower numbers of junction failures recorded as due to lightning.

Figure 3. End junction failure.

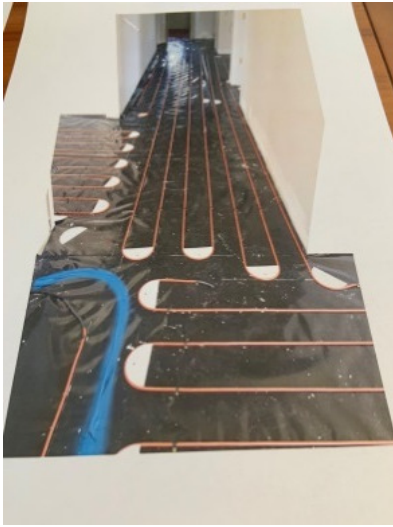
Where lightning surge protection was installed on the active cables at the electrical distribution board and a floor heating cable had failed, with typical lightning strike damage. The layout of the failed cable was traced, and the cable loops were found to be installed at right angles to the other adjacent rooms with undamaged cables. The floor heating cable layout was then noted to be of a similar layout to a roof-mounted, high-gain, television antenna, as shown in Figure 4 [2]. On a number of occasions, the cable layout, such as the one shown in Figure 5, had pointed directly at a severely damaged tree in the garden. Many papers [3,4,5,6]. have addressed the radiative and reception properties of antenna models in relation to the electromagnetic effects of lightning discharges.

Figure 5. Typical floor heating installation.

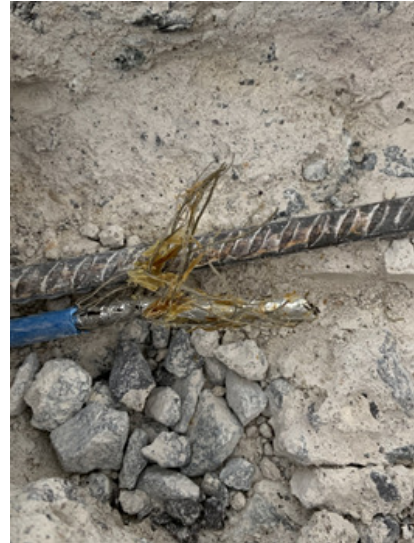
Following a known lightning strike, it is common to find a wax like substance in the earth screen within the shrink tubing at the damaged CTJ or end junction. The short-term, high-voltage and high-current transients, sealed within the shrink tubing, recreate the high temperatures and pressures used to manufacture the thermoplastic insulation. The plastics are partially converted back to the waxes from which they were created. An example is shown in Figure 6 [8].

Figure 6. Creation of wax as a result of lightning strike damage.
